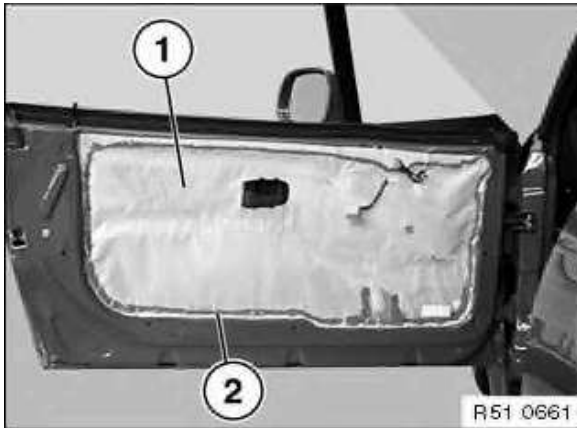
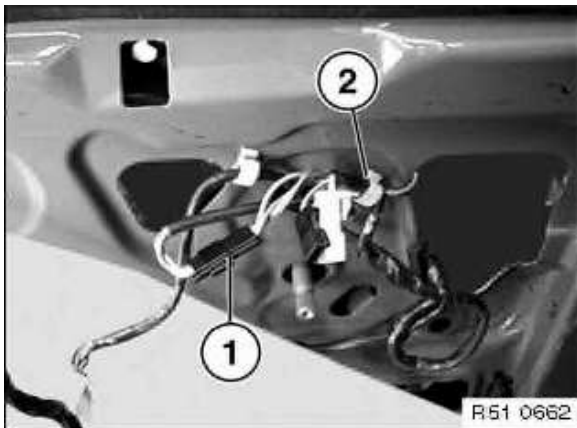
Partially remove foil from front door (1).

If the cement bead (2) is broken, seal with butylene thread
(Sourcing Reference BMW Parts Service).

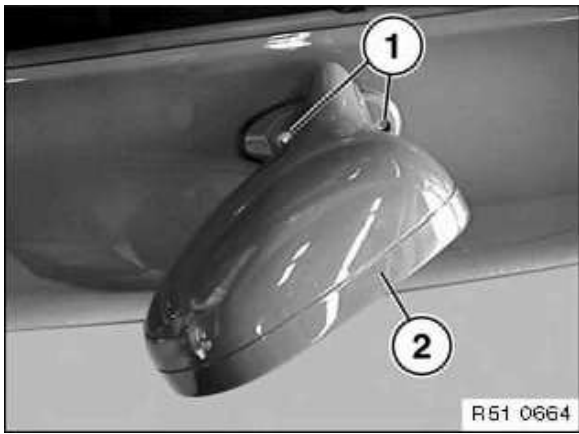
Turn rear-view mirror 90° to face forwards.

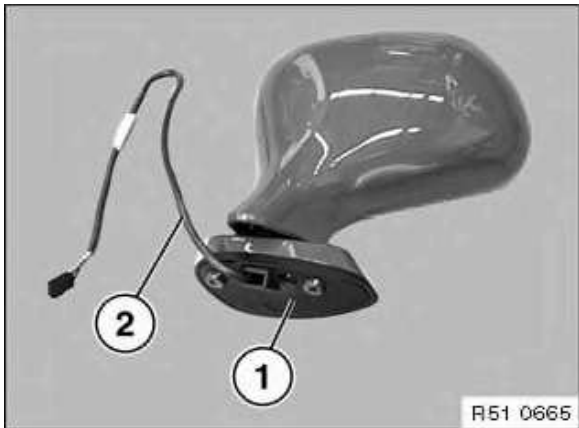
Loosen screws (1).

Remove rear-view mirror (2) and pull out cables.

Tightening torque, refer to Technical Data 51 16 1AZ
