Z3

When crossing the border into countries where vehicles drive on the opposite side of the road to the country in which a vehicle is licensed, the asymmetric wedge on the low-beam headlight must be covered.

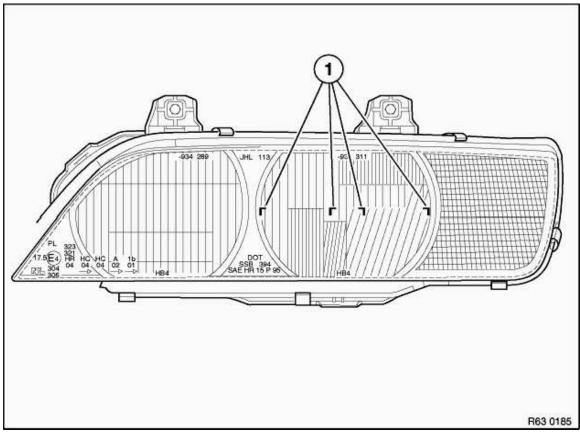
Left headlights in direction of travel:

Marking angles are provided on the reflector.

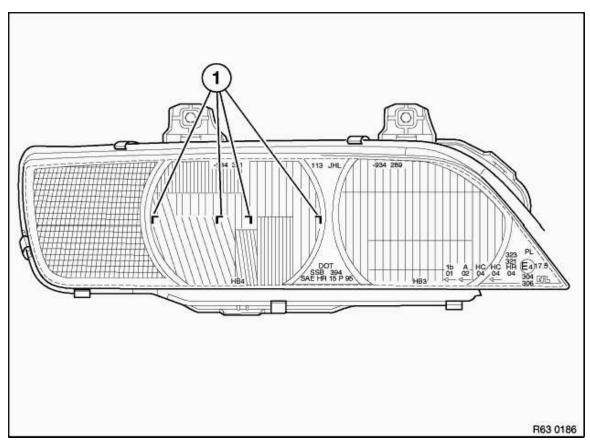
Left headlight in direction of travel:

Marking angles are provided on the reflector.

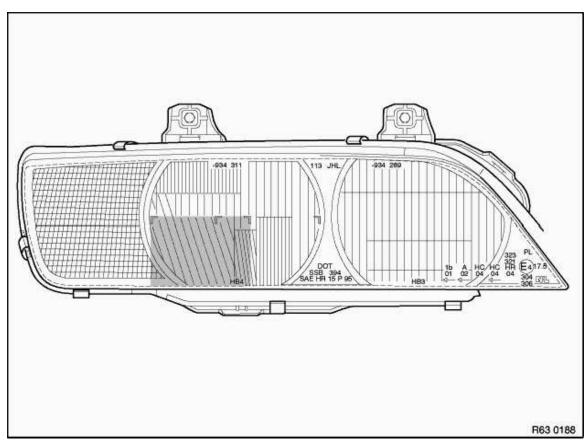
Right headlight in direction of travel:

Covered area of a LHD vehicle in a RHD country.

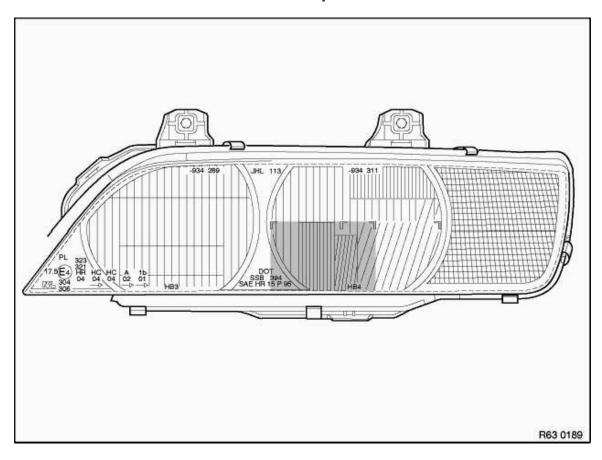
Left headlight in direction of travel:

Covered area of a RHD vehicle in a LHD country.

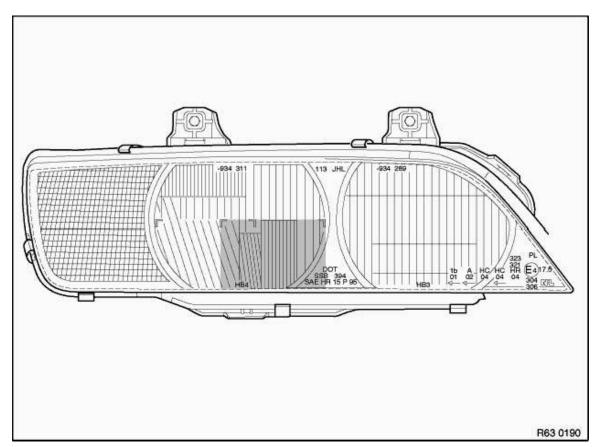
Right headlight in direction of travel:

Covered area of a RHD vehicle in a LHD country.
